## INITIAL INVENTORY AND DOCUMENTATION OF STONE/BRICK-AND-LIME VATS (*BALDI*) IN SOME NORTHERN TOWNS OF THE PROVINCE OF ILOCOS SUR, PHILIPPINES

Fatima Nicetas A. Rabang-Alonzo<sup>1</sup>, Uldarico A. Pacada<sup>2</sup>, Gener A. Retuta<sup>2</sup> and Renato B. Navarro<sup>2</sup>, with M.L. I. Ingel<sup>3</sup>

*This is an initial inventory and documentation of remaining, abandoned and non-functioning vats, locally referred to as baldi, in some northern towns of Ilocos Sur, many of which are in various states of human-mediated damage and natural deterioration. It was undertaken by faculty proponents and students of the College of Architecture of the University of Northern Philippines, Vigan City with a local anthropologist for the period 2017 to 2018. The research sought to establish the significance of the vats in the cultural life of the province. As a descriptive method of research of the qualitative type, the project basically aimed to identify the location of the vats, determine their construction methodology and materials of construction, inscribe their architectural character and features, evaluate their current physical condition and contexts, and ascertain their owners

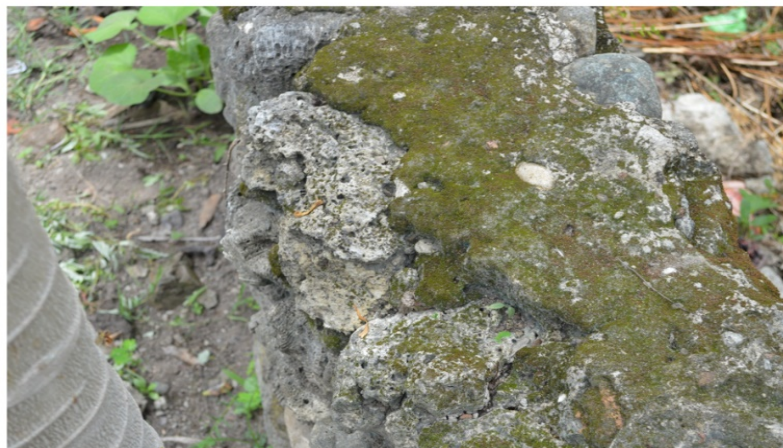
**1.1. Materials – Coral stones, boulders, stones, lime mortar**

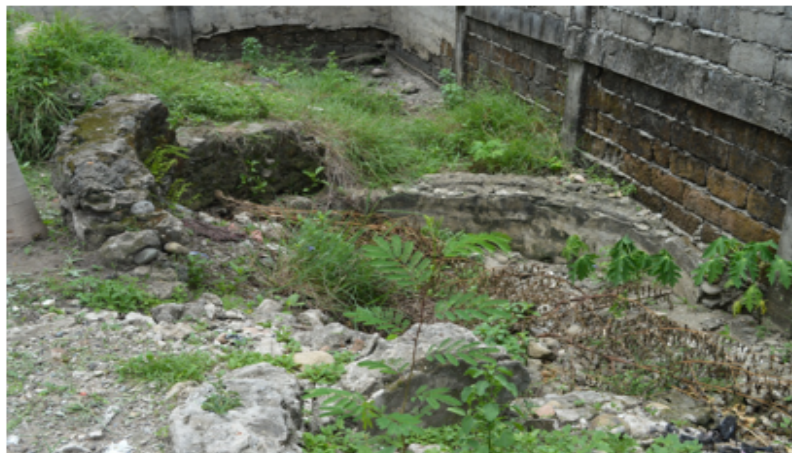
<b>Site No.</b>	<b>Location</b>	<b>Remarks re location, condition of the vats, present use, etc.</b>	<b>No. of vats</b>	<b>Documentation</b>
1.1	Sinait (Barangay Magsaysay)	<ul style="list-style-type: none"> <li>• Residential area</li> <li>• Vat is largely ruined and partly demolished</li> </ul>	<b>1</b>	<i>Only photographed</i>

**1.1. View of the vat ruins**

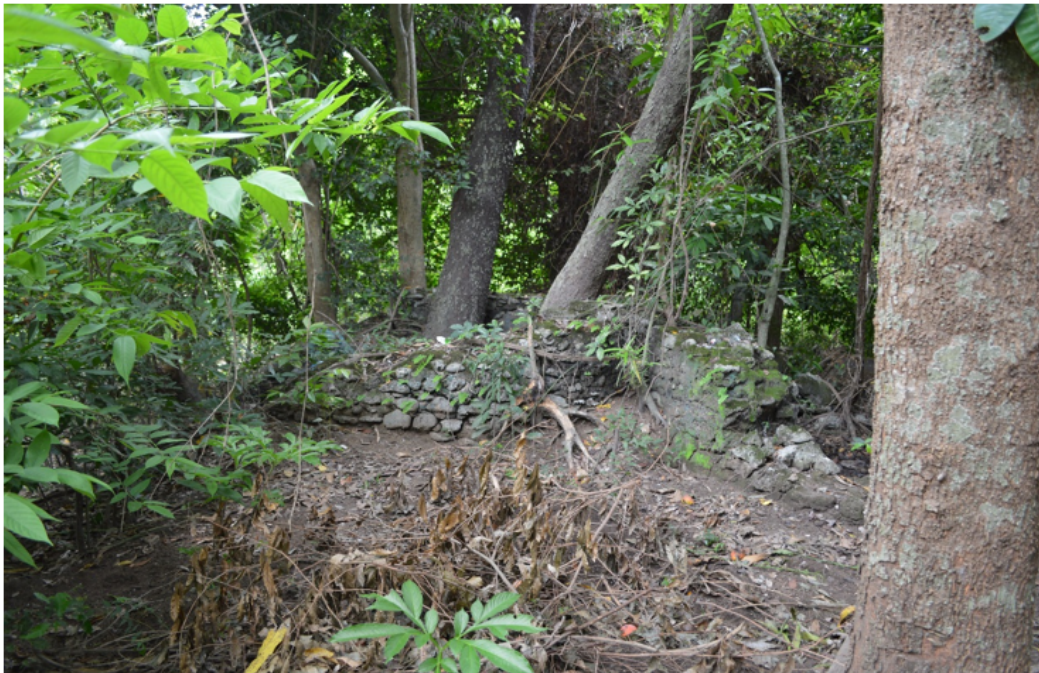
1.2	Sinait (Barangay Magsaysay)	<ul style="list-style-type: none"> <li>• Residential, with a small forested area (south of Site 1.1)</li> <li>• Vat is almost totally ruined by overgrowth (trees &amp; other plants)</li> </ul>	<b>1</b>	<i>Only photographed</i>

**1.2. View from the South**

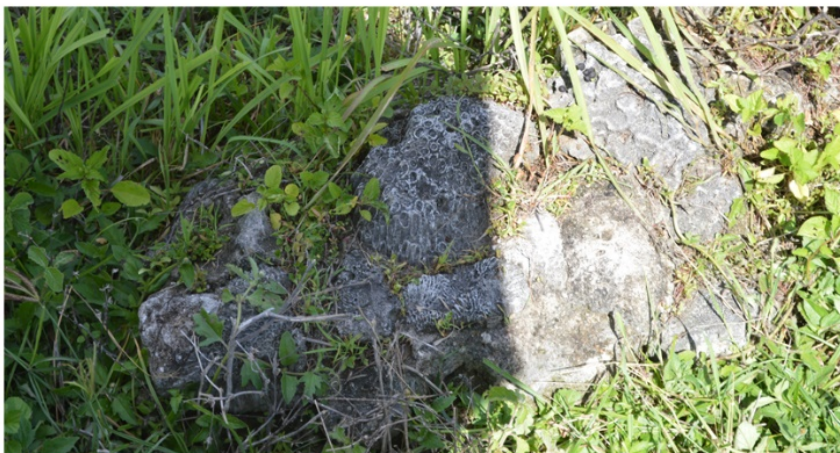
**2.1. Materials - Coral stones, boulders, stones, lime plaster**

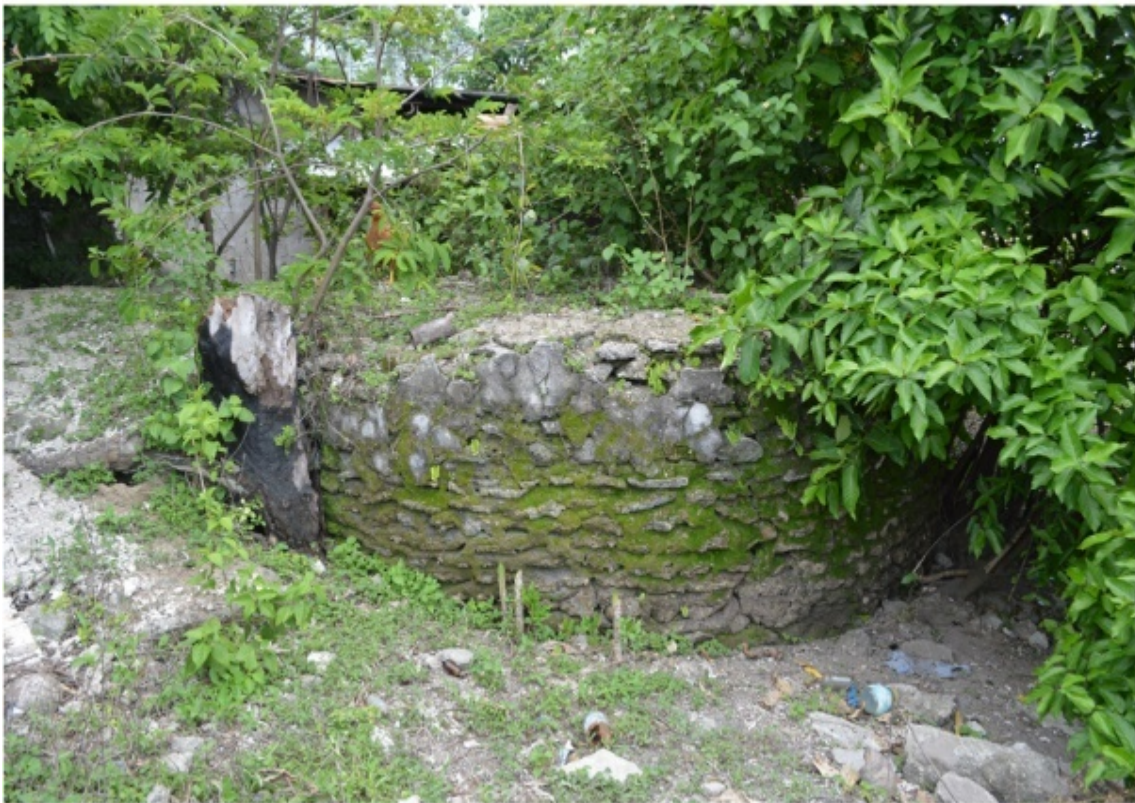
4.2	San Juan (Barangay San Isidro Norte)	<ul style="list-style-type: none"> <li>• Residential area</li> <li>• The vats are with overgrowth</li> </ul>	2	<i>Fully documented</i>

**4.2. Closer view from Northwest**

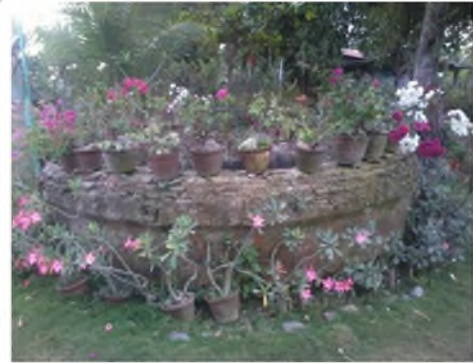
6.1	Magsingal (Barangay San Basilio)	<ul style="list-style-type: none"> <li>• Residential area</li> <li>• Vat is presently utilized as landscape feature</li> </ul>	1	<i>Fully documented</i>

Brick and lime vat used as flower pot stand

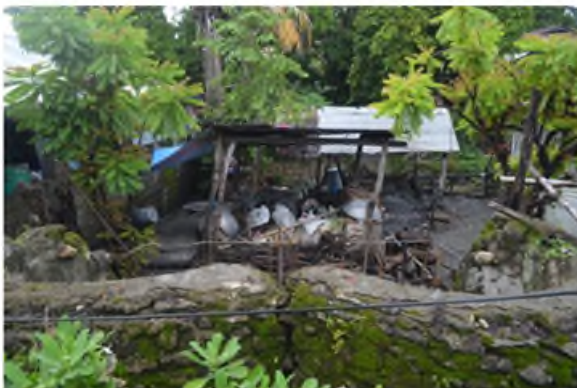
6.2. Closer view of the vat wall

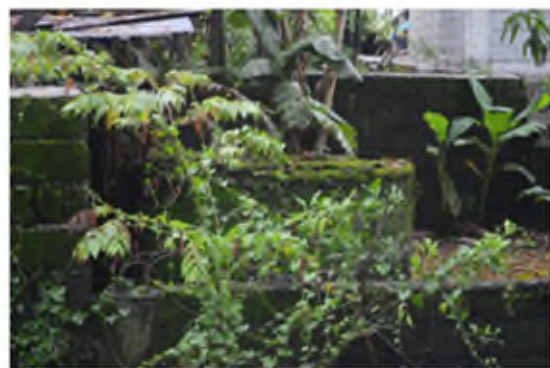
6.2. Vat covered with moss

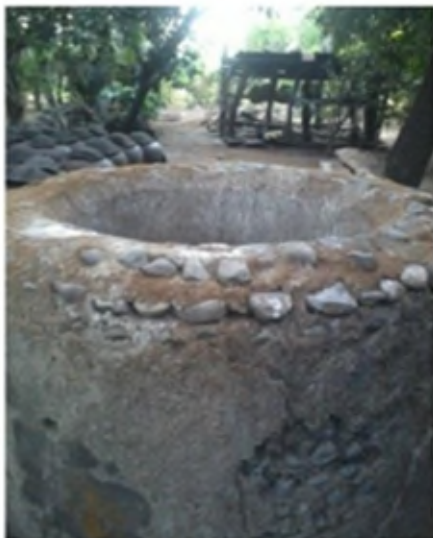
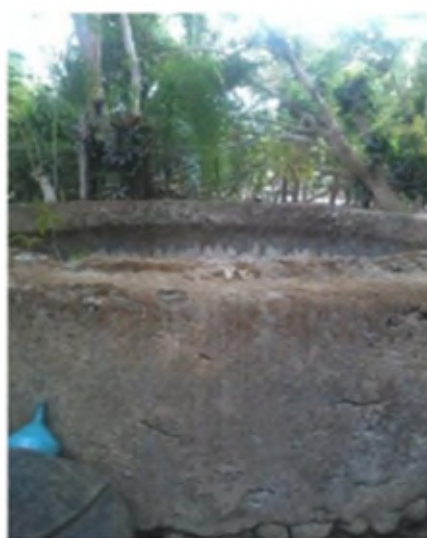
**7.1 Vat walls of stone and lime**

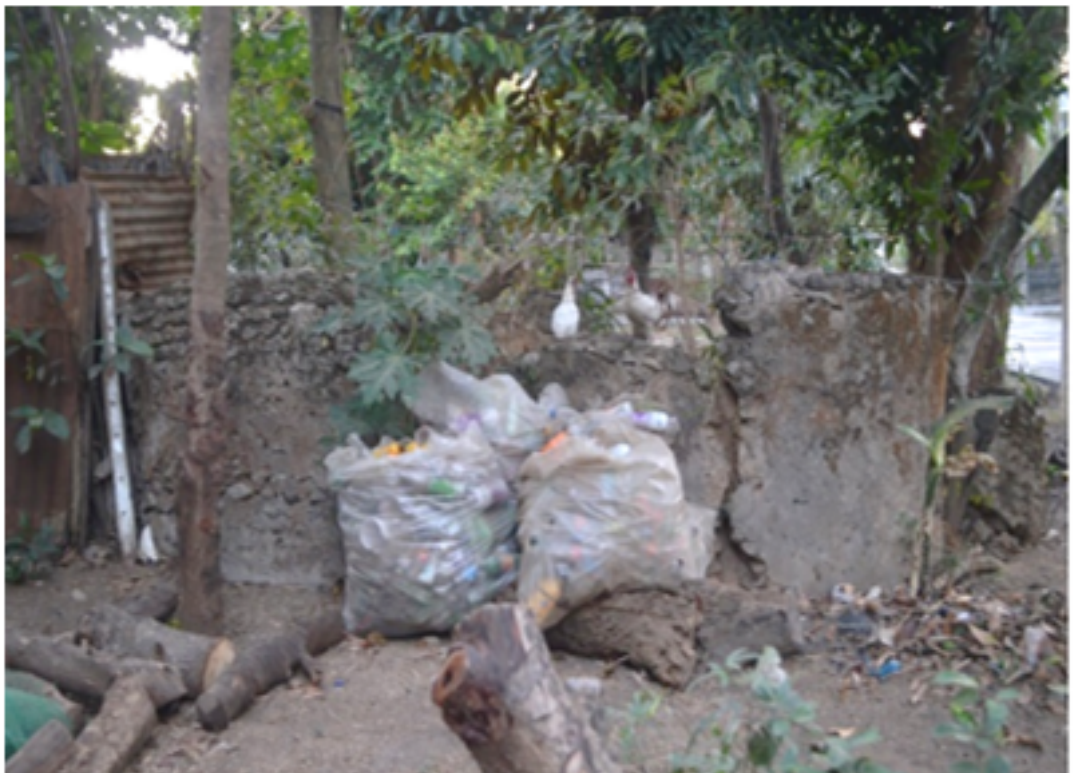
8.1	San Ildefonso	<ul style="list-style-type: none"> <li>• Residential</li> <li>• On a garbage area, with overgrowth</li> </ul>	2 (1 pair)	<i>Fully documented</i>

**Vat ruins**
